TORLON® 4XCF PAI

Reliable long term performance in High Pressure Microturbine Valve for Off-Shore Equipment

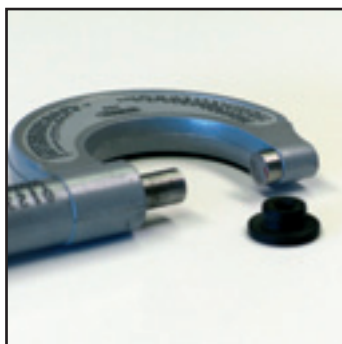
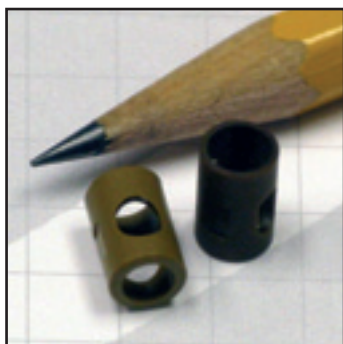
During the design phase of a micro-turbine system used in the offshore industry, the project engineer consulted with Quadrant to identify a strong, stable sealing material that could withstand extraordinarily high PV loading (pressure and velocity) and temperatures with minimal wear over extended service periods. Quadrant's carbon fibre reinforced TORLON® 4XCF (7130) PAI was the material chosen and machined into precision disk shaped parts for the application.

Application requirements	TORLON® 4XCF PAI performance
Micro-turbines are small scale energy generating devices that contain a gas valve with a "shear disk" that acts as a seal for the valve. High pressures create the risk of distortion and leakage problem in the application.	TORLON® 4XCF PAI (30% carbon-reinforced) combines high strength and stability under high pressure conditions to ensure reliable long term performance. The material has a very low coefficient of linear thermal expansion that ensures dimensional stability at temperature extremes.
The high speed of the "shear disk", and the dynamic loads on it create potential wear life problems for the micro-turbine units.	The inherent wear resistance and low coefficient of friction of TORLON® 4XCF PAI allow the shear disk to perform reliably long term.
Precision tolerance control is required to ensure reliable operation of the micro-turbines.	TORLON® 4XCF PAI is easily machined to the close tolerance that the precision parts require.
