Rubber Blooming

What is That White Dust on The Surface of my Rubber Seal?

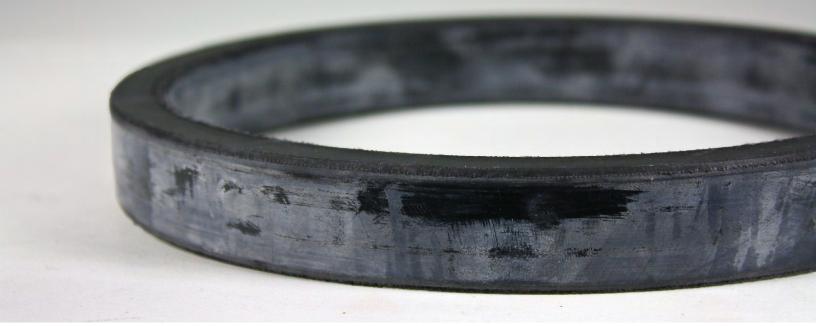
This white, milky substance can appear on rubber components is called 'bloom'. Rubber blooming occurs when compounding additives migrate to the material's surface. It most commonly appears on nitrile, hydrogenated nitrile, and neoprene/chloroprene compounds.

While rubber blooming may not be aesthetically pleasing, it is normal and purely superficial. It does not affect the quality of the moulded product. If its appearance is unacceptable, it can be removed easily by washing the part in water or a light mineral oil.
